TECHNICAL REPORT ARCCB-TR-99010

**ANALYSIS OF A PISTON EXPERIENCING
ENVIRONMENTALLY-ASSISTED CRACKING
AS A RESULT OF COMPRESSIVE OVERLOADING**

**E. TROIANO
G. N. VIGILANTE
J. H. UNDERWOOD
C. MOSSEY**

JUNE 1999

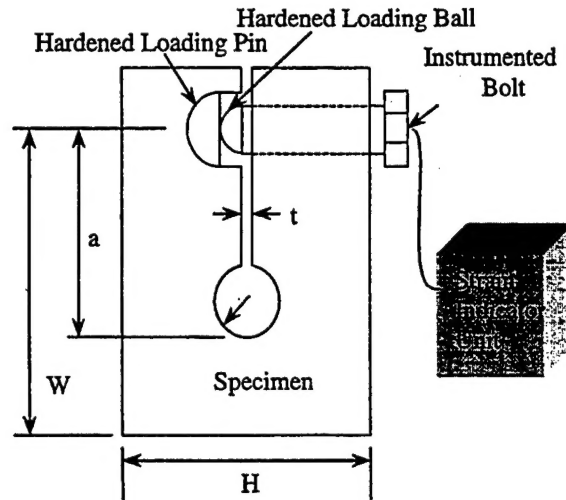
Figure 3. Setup and configuration for the modified bolt-loaded compact testing.

Our approach included modification of the bolt-loaded compact specimen currently being considered for addition to ASTM Standard 1681, "Determining a Threshold Stress Intensity Factor for Environment-Assisted Cracking of Metallic Materials Under Constant Load." Since the piston does not have any sharp stress risers, we felt that the inclusion of a sharp precrack into the specimen would not adequately model this geometry. Therefore, we opted for the inclusion of a 3/8-inch diameter through hole (Figure 3). The base materials chosen for the testing were Maraging 200 and an A723 Grade 2 pressure vessel quality steel, both heat treated to yield strength of 1300 MPa. These materials were chosen because of their unique combination of strength and toughness that was required for the component. Nickel-based alloys would have been the first choice for resistance to hydrogen, however none possessed the required strength. The hydrogen barrier coatings investigated and their thicknesses are included in Table 4.
